3 Exterior

3.1 Front - Back Entrance

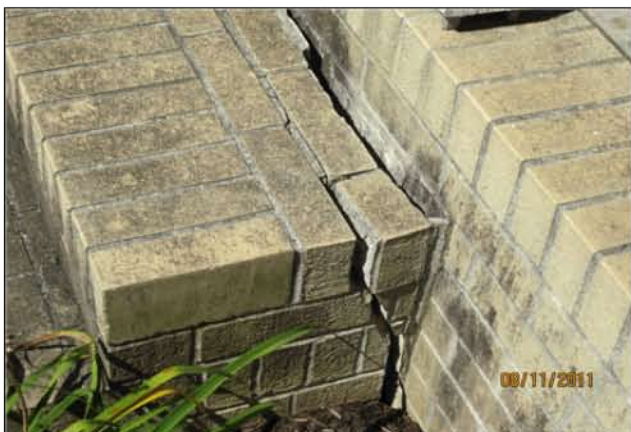
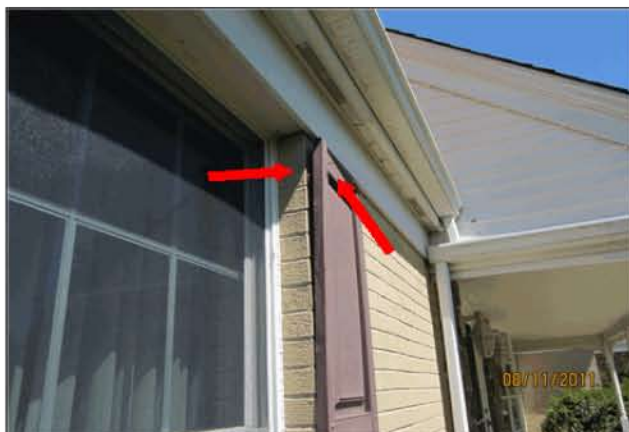
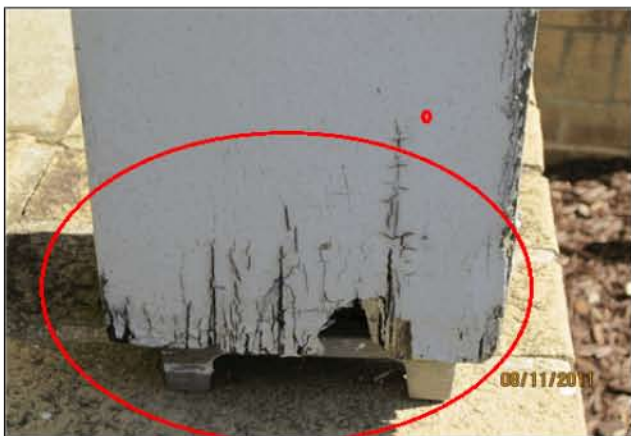
3.1.2 Front Entrance Conditions

Front door maintenance is needed. Door should be sanded ,stained and re-varnished, Not doing this will cause further damage. Front step is pulling away from porch. This may be due to settlement of footing. Steps should be repaired before settlement , to stop water penetration from going down wall and freezing. Shutter screws are coming loose and shutters are pulling away from house. Base of columns at front porch - wood is very soft at columns bottom. Need Repair in near future to prevent settlement of porch roof.

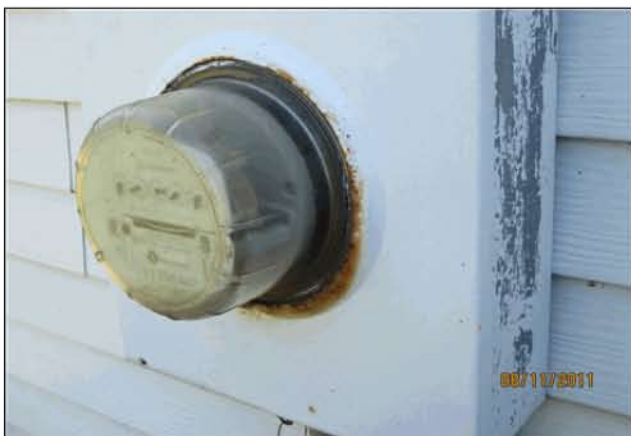
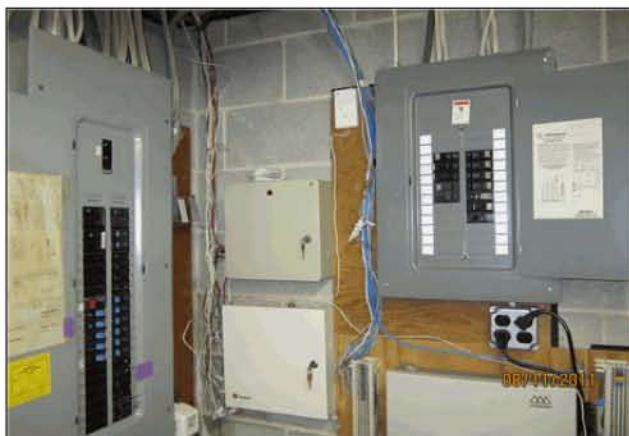
7.1.3 Electrical Service Conditions

Rust and corrosion around meter socket - recommend further evaluation by a licensed electrician .

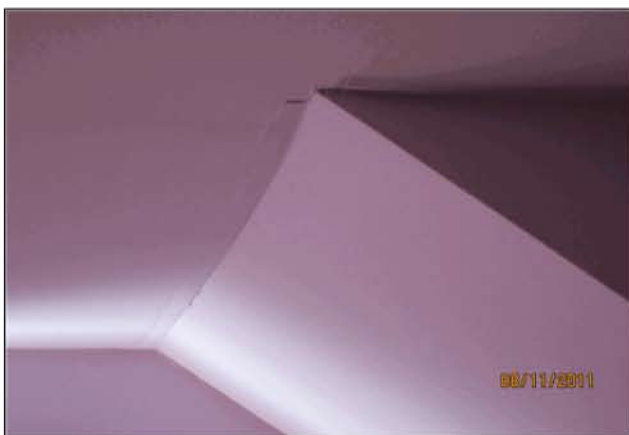
9.1.2 Ceiling Conditions

The interior ceilings are drywall. Bedroom at top of stairs to left the spackle and tape is pulling away from ceiling in corner . There are no signs of water damage. Respackle, tape and paint.

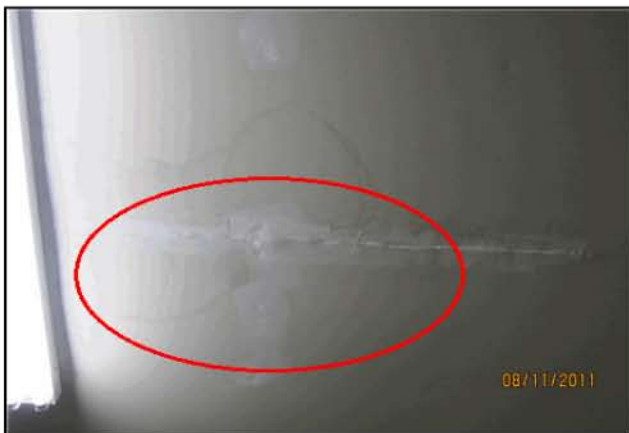
13.1.3 Ceiling Conditions

There are signs of water on ceiling from louver vent above. Call a qualified contractor.

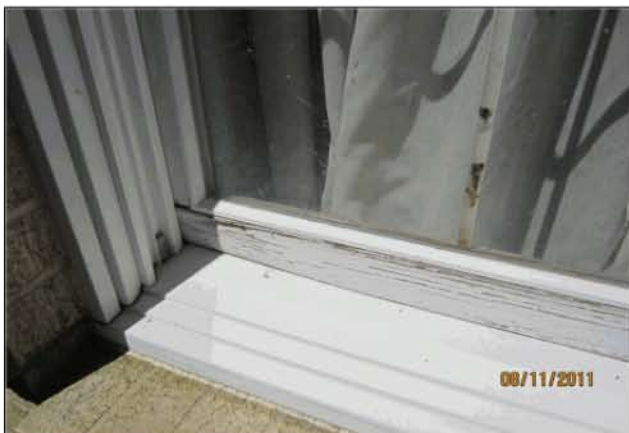
13.1.5 Window Conditions

Garage window lower sash needs to be replaced

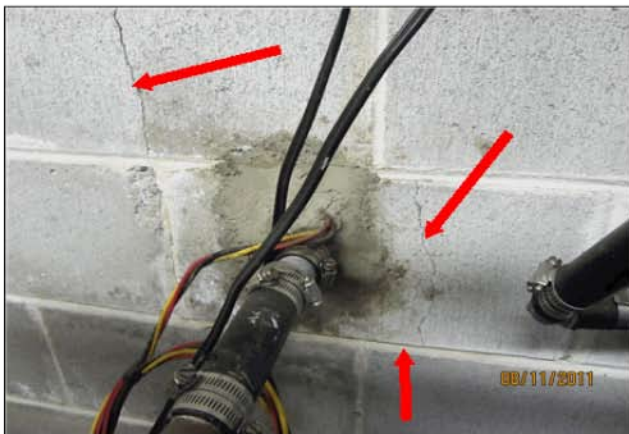
14.1.3 Foundation Condition

There were cracks in wall where the main line from the well entered the house probably done at time of installation. This should be monitored .
